# Your property.

# Checked.

| PROPERTY | Example property · North Cornwall |
| VISIT TYPE | Routine external check |

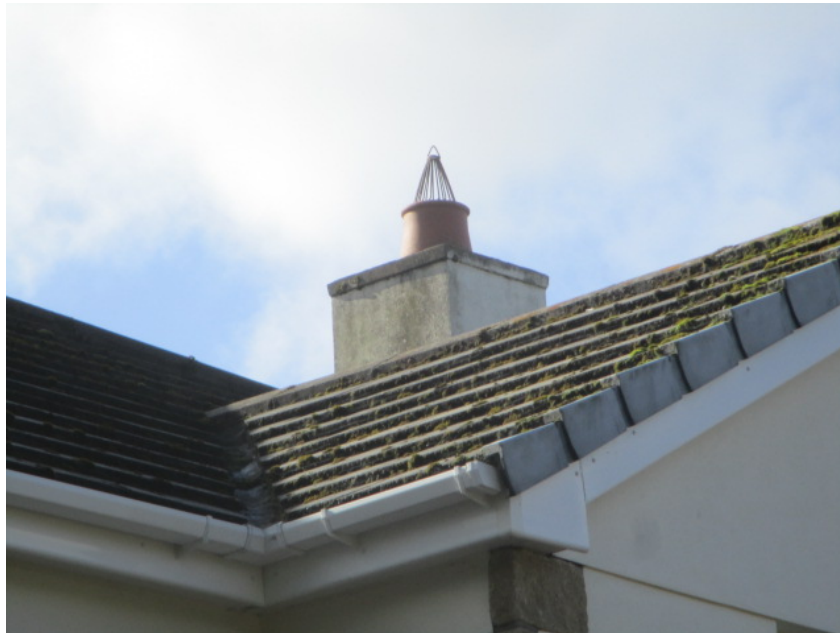
Moss and vegetation are visible on sections of the roof slope and in and around the gutter line. Ongoing accumulation may affect drainage and maintenance.

Roof slope with moss growth

- Arrange routine gutter and downpipe clearance.
- Consider roof-level cleaning/maintenance by an appropriate contractor.

| REF | ACTION | PRIORITY | OWNER / TRADE | STATUS |
|---|---|---|---|---|
| 02 | Review moss on roof slopes during maintenance | <b>LOW</b> | Approved contractor | <b>OPEN</b> |

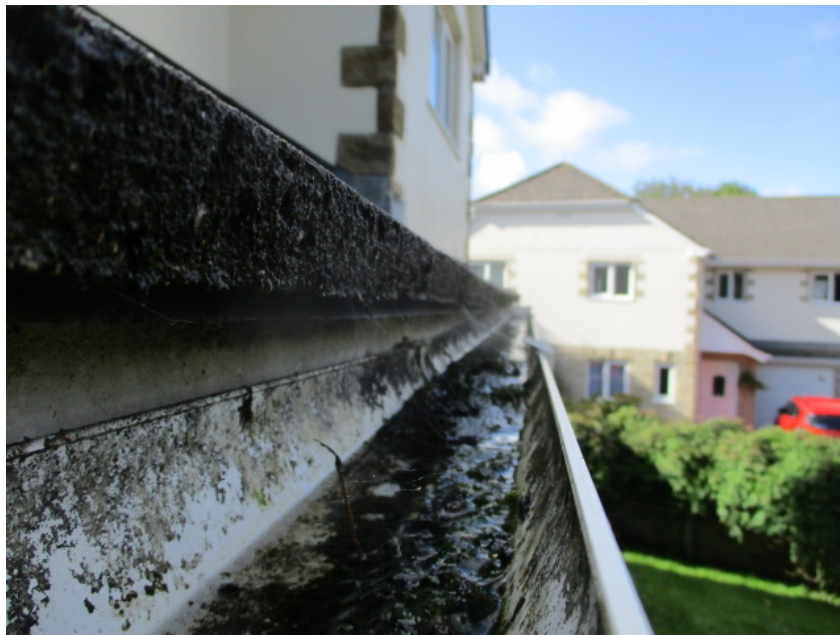
Front elevation gutter debris

| REF | ACTION | PRIORITY | OWNER / TRADE | STATUS |
|---|---|---|---|---|
| 01 | Arrange gutter clearance / clean | <b>MEDIUM</b> | Approved contractor | <b>OPEN</b> |

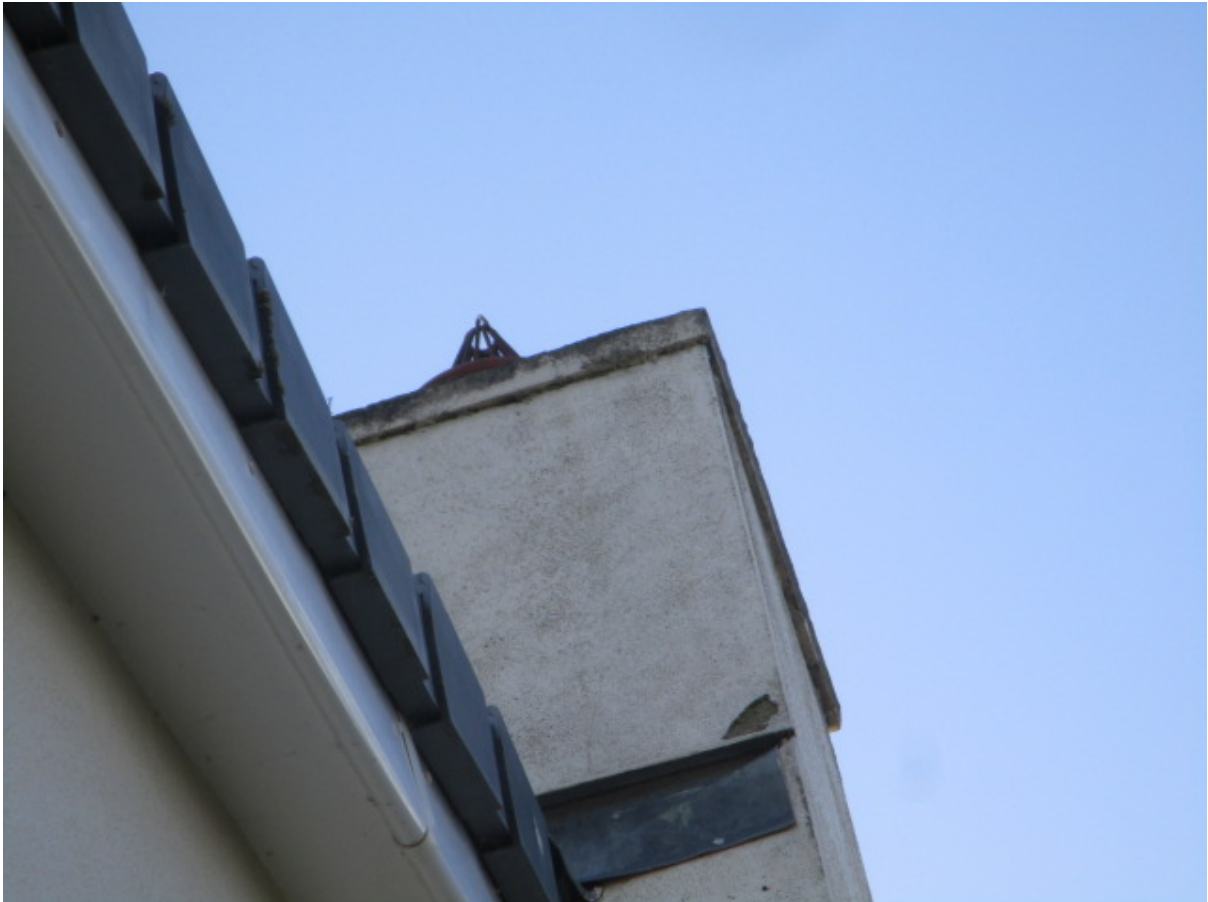
A small localised defect/chip is visible to the rendered chimney stack. From ground level this appears minor, but it should be monitored and inspected during future roof maintenance.

Localised render defect

- Monitor at the next visit. If condition worsens, request contractor review.

| REF | ACTION | PRIORITY | OWNER / TRADE | STATUS |
|---|---|---|---|---|
| 03 | Monitor chimney render defect at next visit | <b>LOW</b> | Property Watch | <b>OPEN</b> |
